Manhole Inspection Summary

Manhole # S37AA_020MH

Insp Date: **11/20/08 11:00 AM**

Location Address: **cross from 540 e monument st**

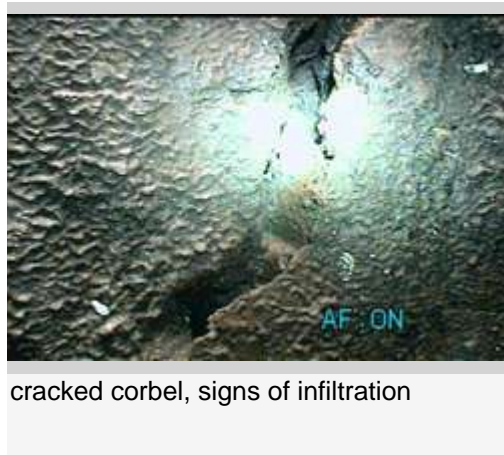
Defect 4

Condition: ☐ Sound ☒ **Cracked** ☐ Root Intrusion ☐ Loose Brick ☐ Deteriorated

Infiltration: ☐ None ☐ Joint ☒ **Cracks** ☐ Mortar ☐ Roots ☐ Wall

cracked corbel, signs of infiltration

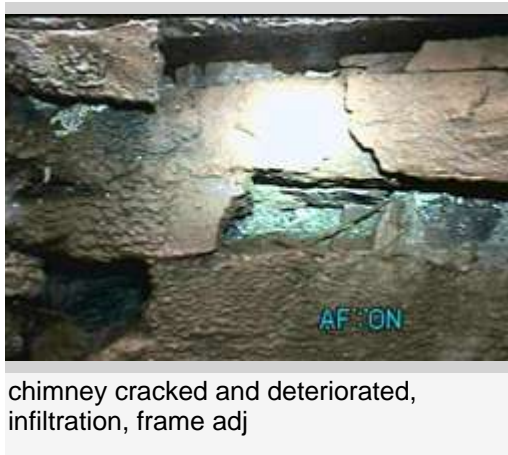
Defect 3

Condition: ☐ Sound ☒ **Cracked** ☐ Root Intrusion ☒ **Loose Brick** ☒ **Deteriorated**

Infiltration: ☐ None ☐ Joint ☒ **Cracks** ☐ Mortar ☐ Roots ☐ Wall

chimney cracked and deteriorated,
infiltration, frame adj

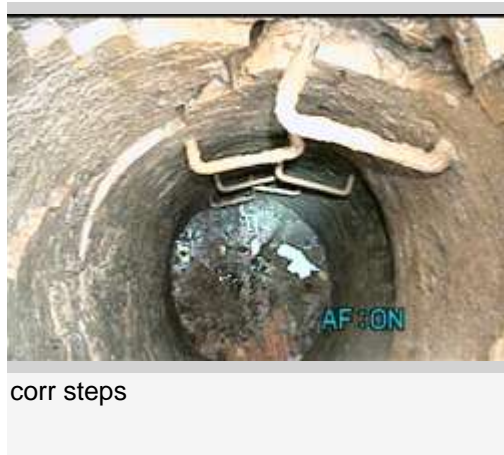
Defect 2

Count: **6** Missing: **0** ☒ **Corroded**

corr steps

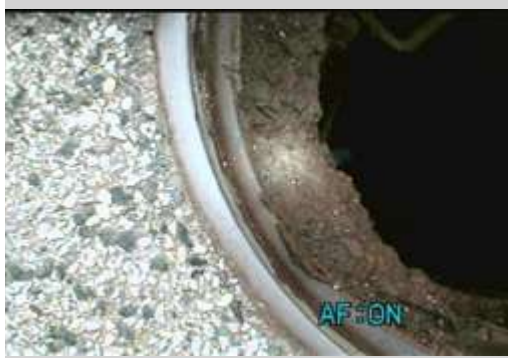
Defect 1

Offset: **4** (in.)

offset
